Close Out Report for the Combined Decommissioning Programmes for Northern Producer FPF Float-off and Disconnection of Risers and Pipelines

| Document ID: | | M4109-ENQ-NPR-DN-00-REP-0022 | |

1. INTRODUCTION

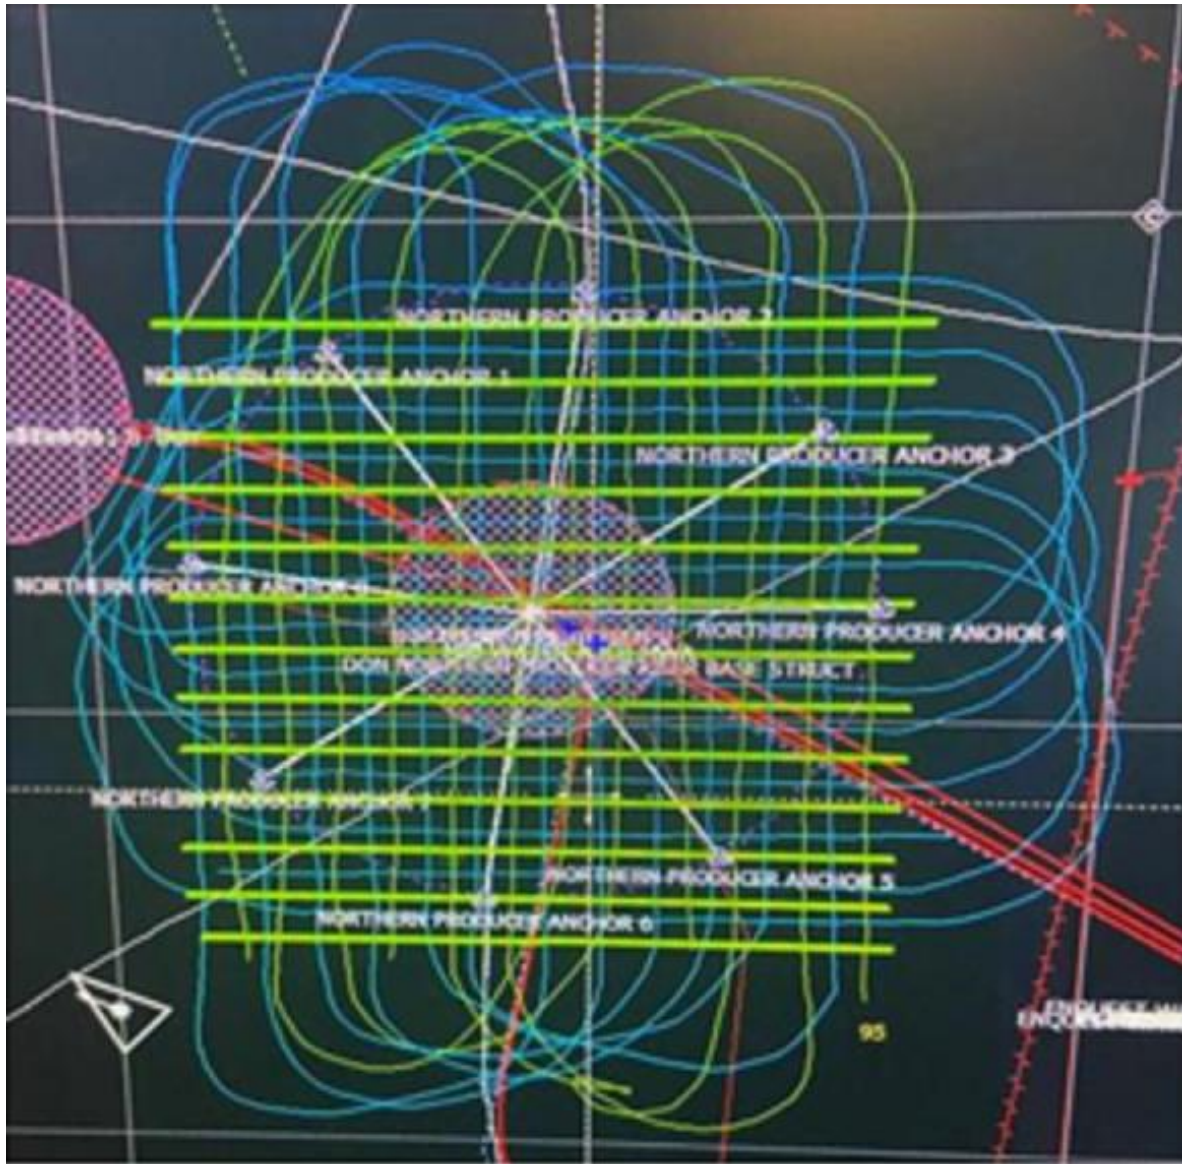
Figure 3.9.1: Trawl sweeps using mimic fishing gear

The thin blue and green lines show the vessel tracks.

A trawl sweep was conducted by a Scottish Fishermen's Federation representative using trawl mimic gear and trawl fishing equipment deployed from the MV Endurance LK416 vessel between 19 April and 24 April 2023. Trawl mimic gear is used first to reduce the potential for damage to trawl fishing equipment. A clear seabed certificate was issued 22 April 2023 (Figure 3.9.2).

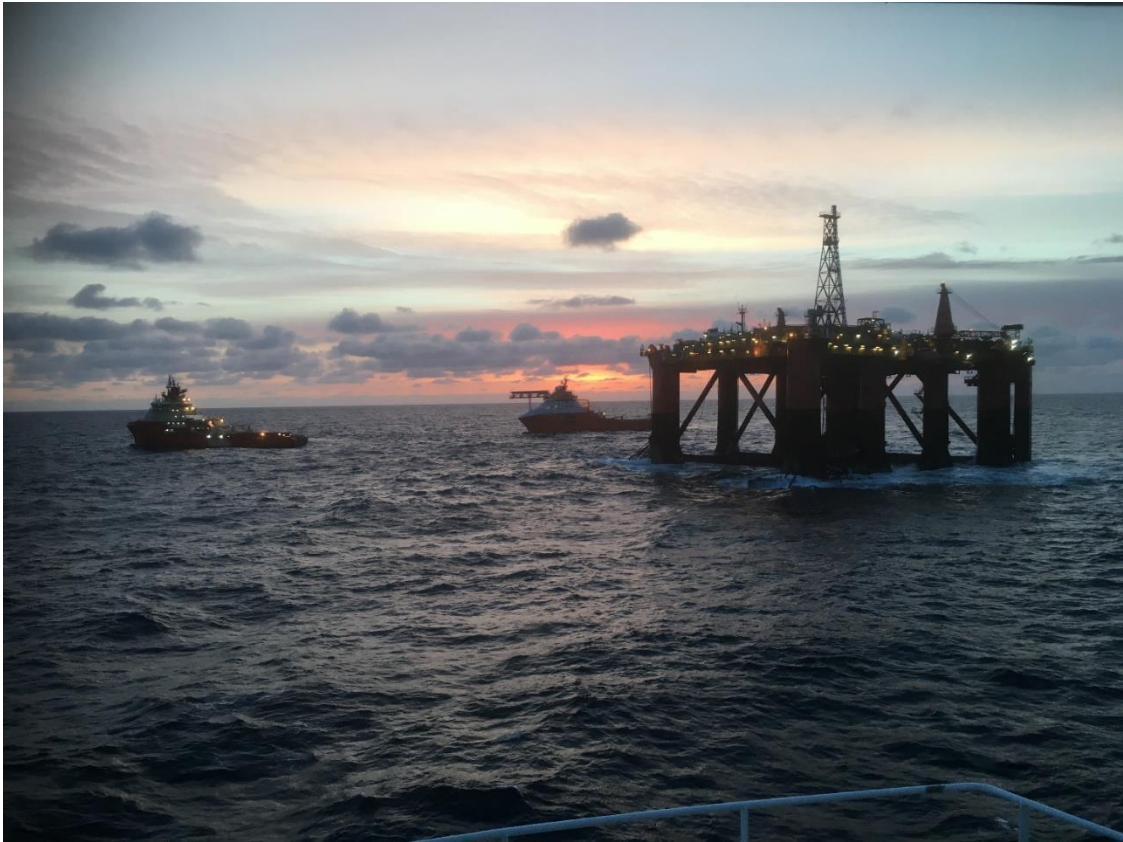
Figure 9.1.1: NP FPF under tow using Anchor Handler Vessels ('AHV')

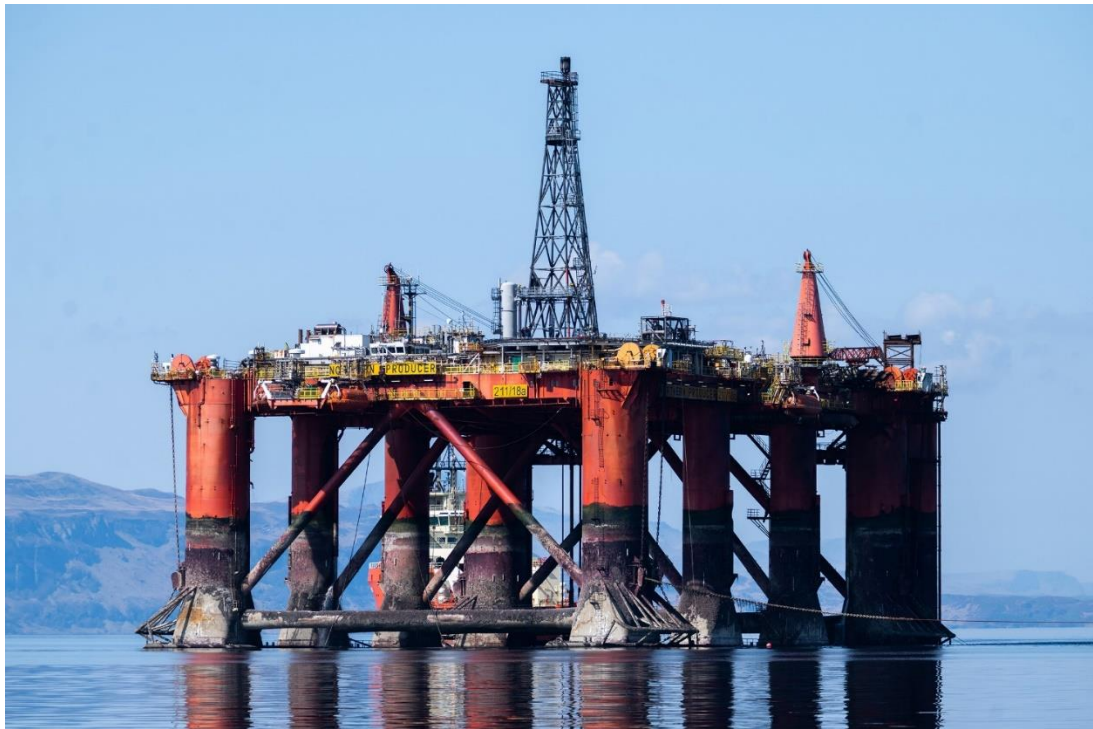
Figure 9.1.2: Northern Producer near Kishorn Port and Dry Dock

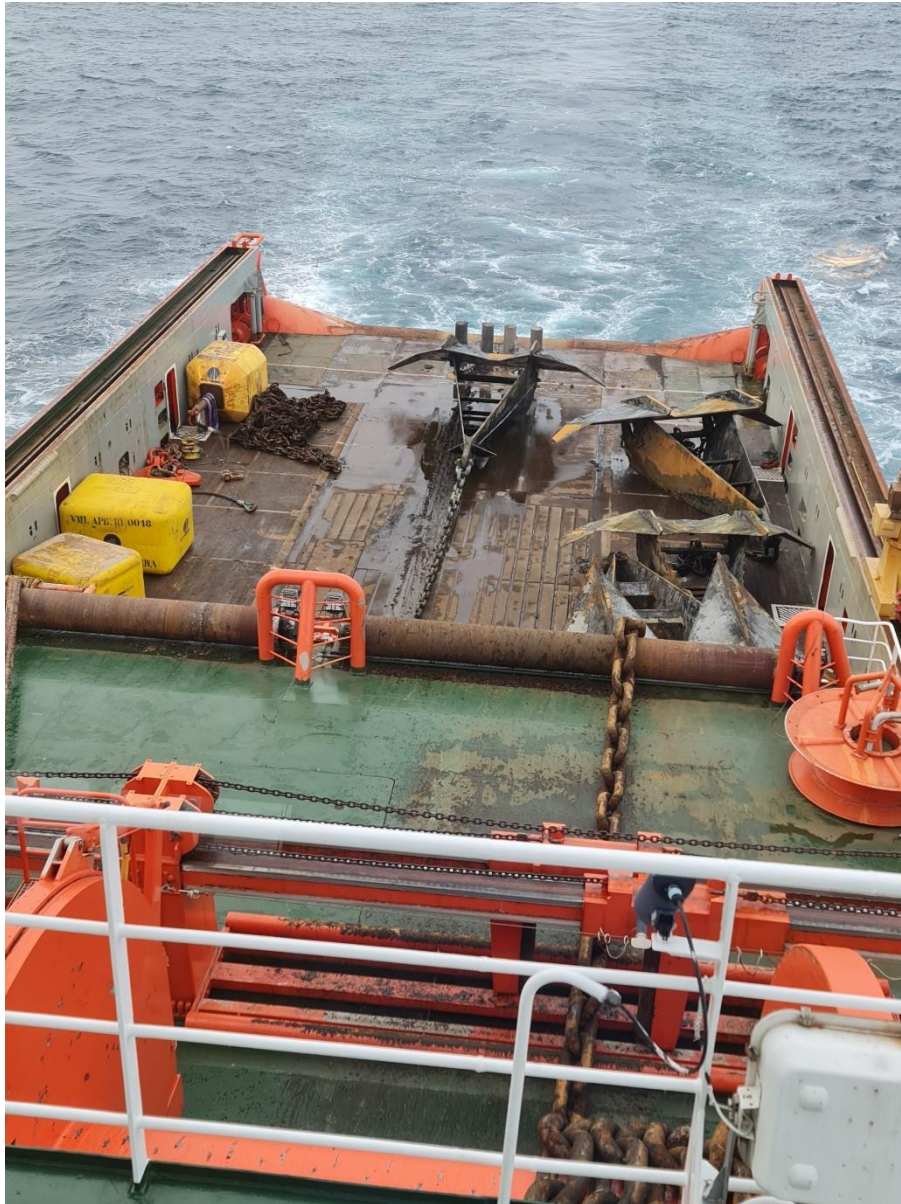
Figure 9.2.1: Northern Producer anchor & chain recovery

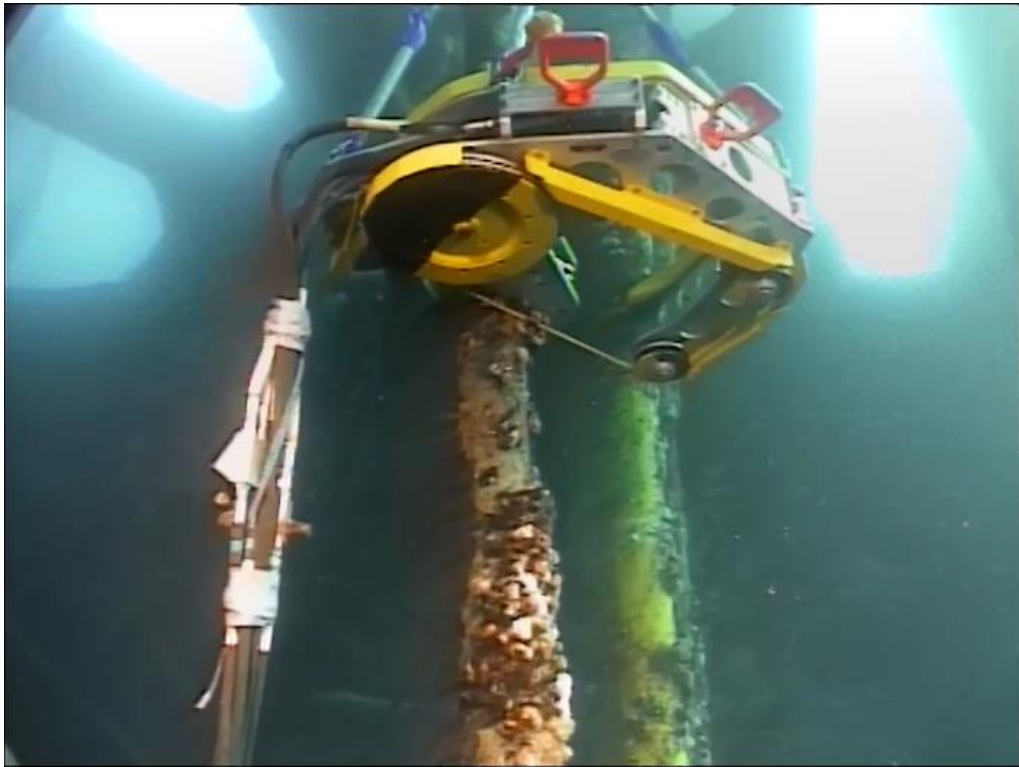
Figure 9.3.1: DWCM in position on riser PL2574

The riser cutting durations varied between 17 and 61 minutes (Table 3.5.1). On completion of the first cut (PL2579) the DWCM was retrieved to deck to allow inspection of the diamond wire for wear

and tear. The diamond wire was replaced after the first cut and after some of the subsequent cuts as well.

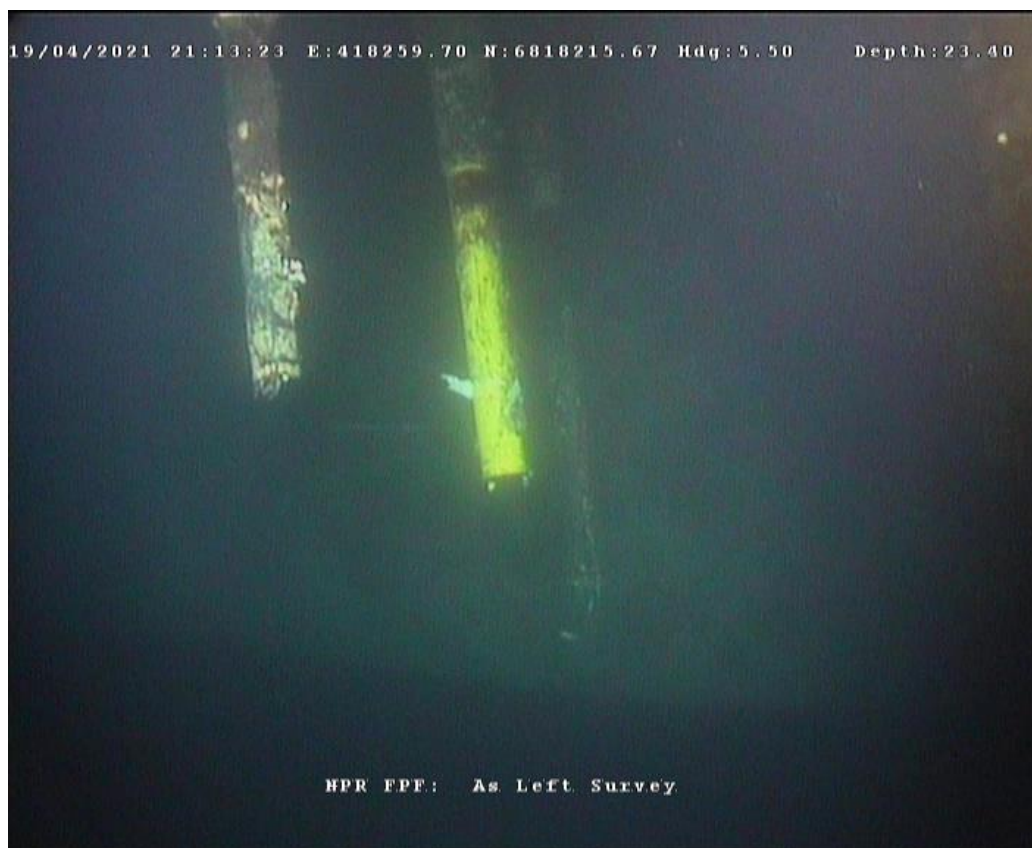
Figure 9.3.2: Cut flexible riser and umbilical

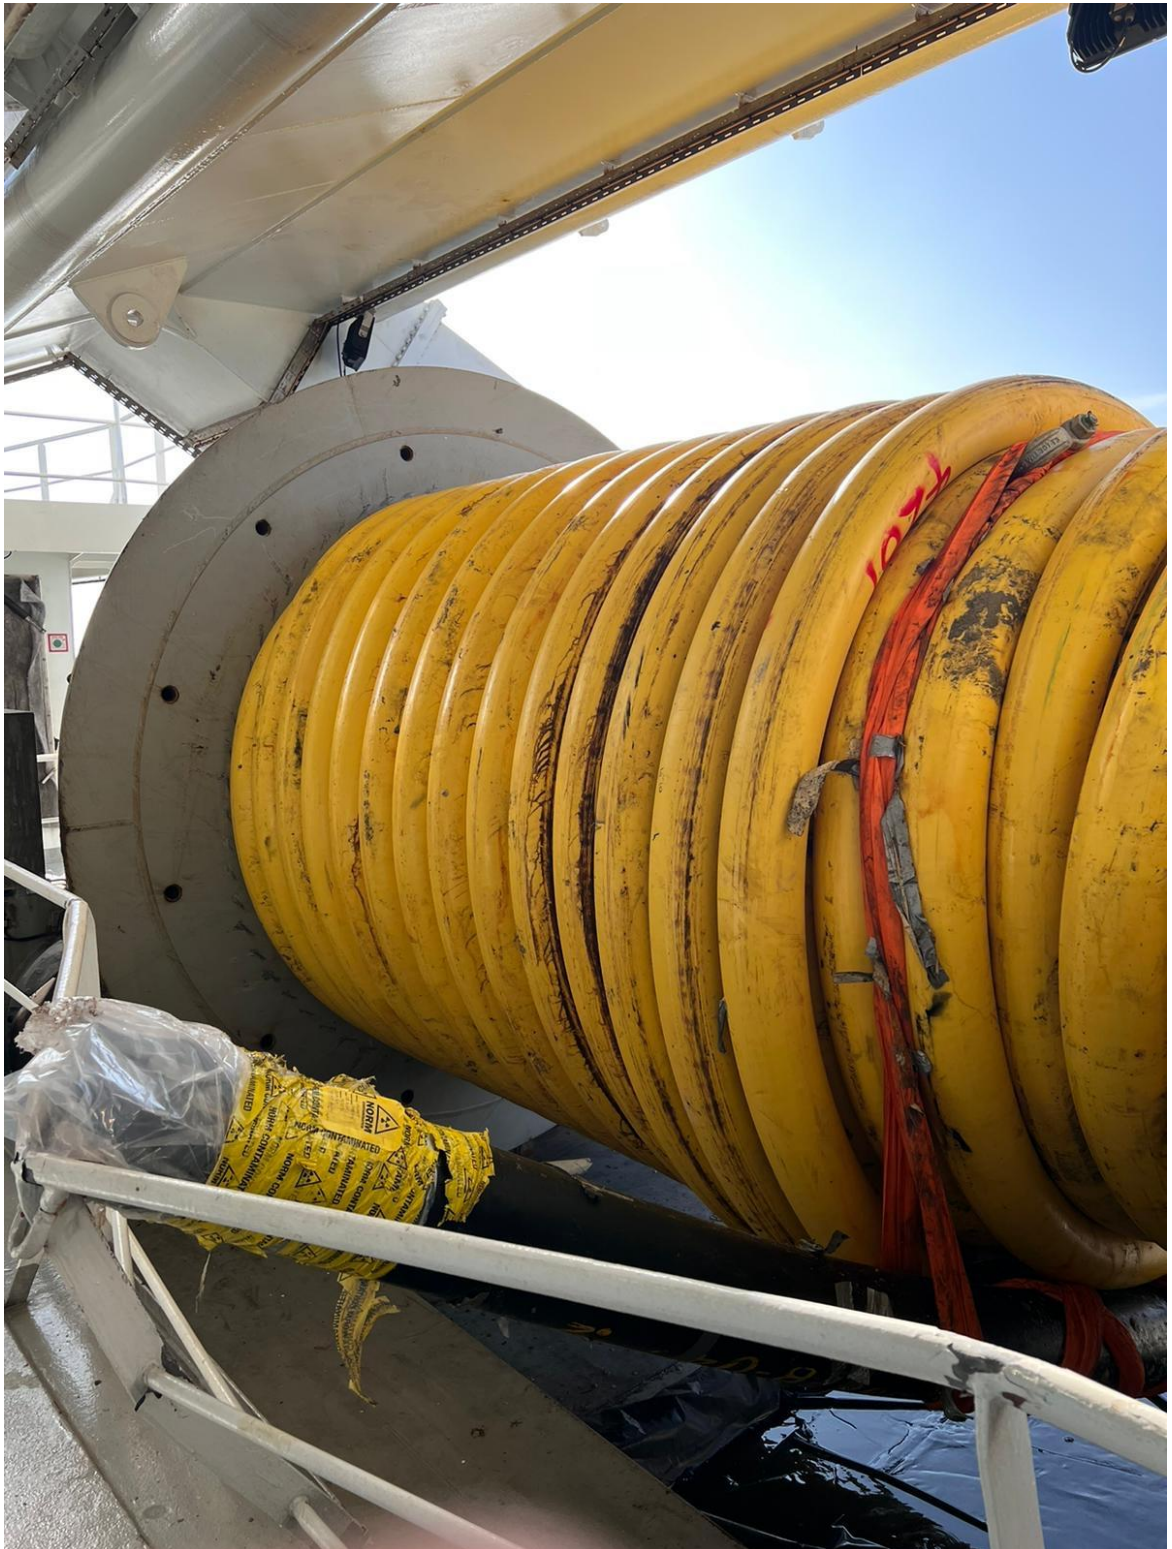
Figure 9.4.1: Umbilical riser on AHV drum

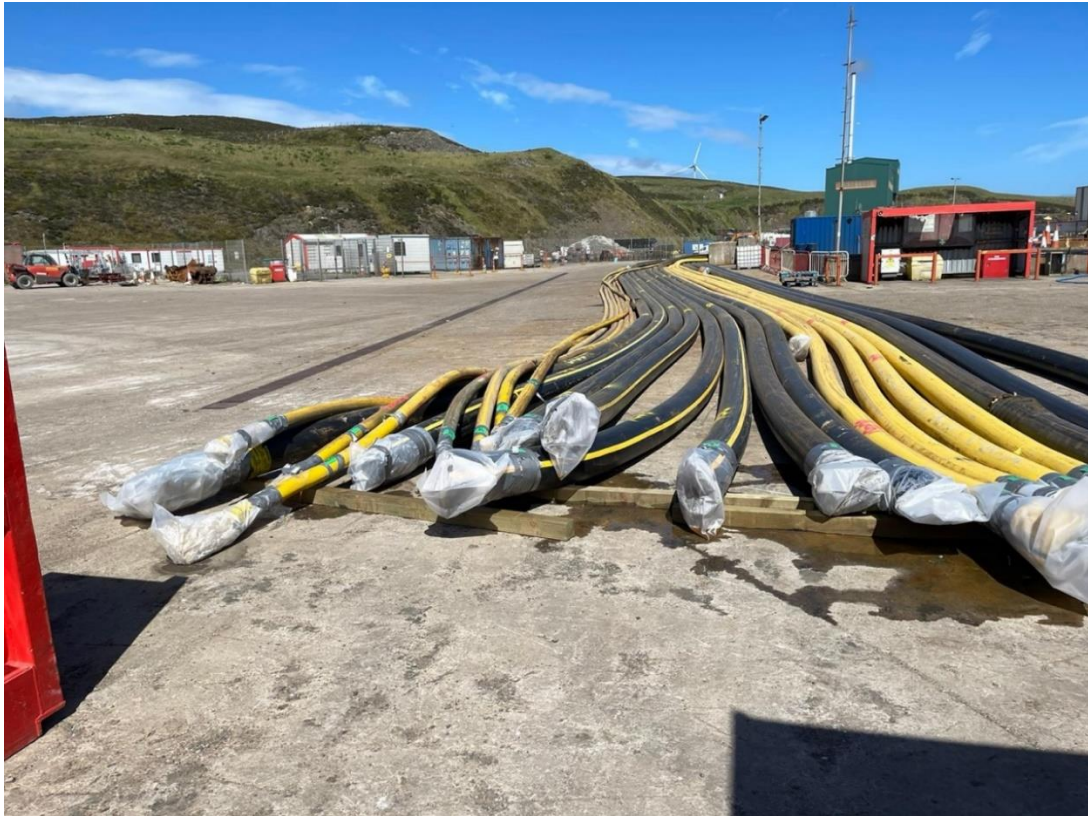
Figure 9.4.3: Flexible risers and umbilicals risers in Lerwick

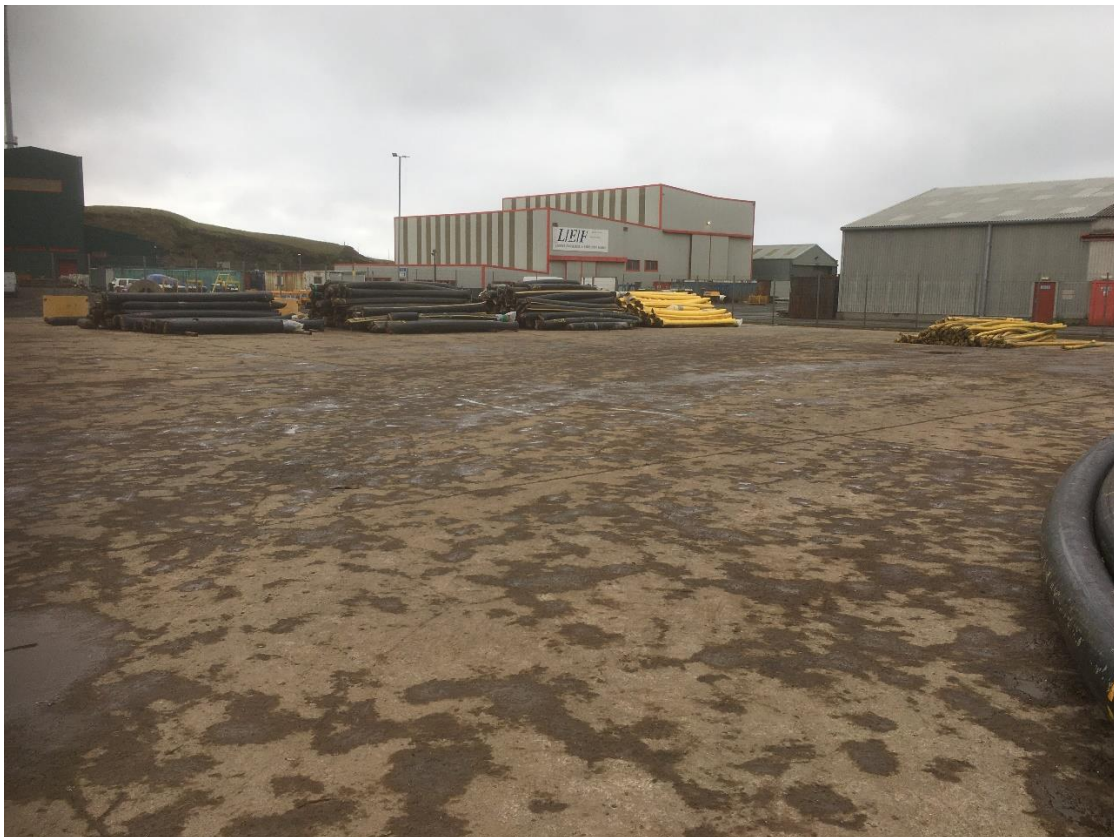
Figure 9.4.4: Flexible risers and umbilical risers stacked in Lerwick

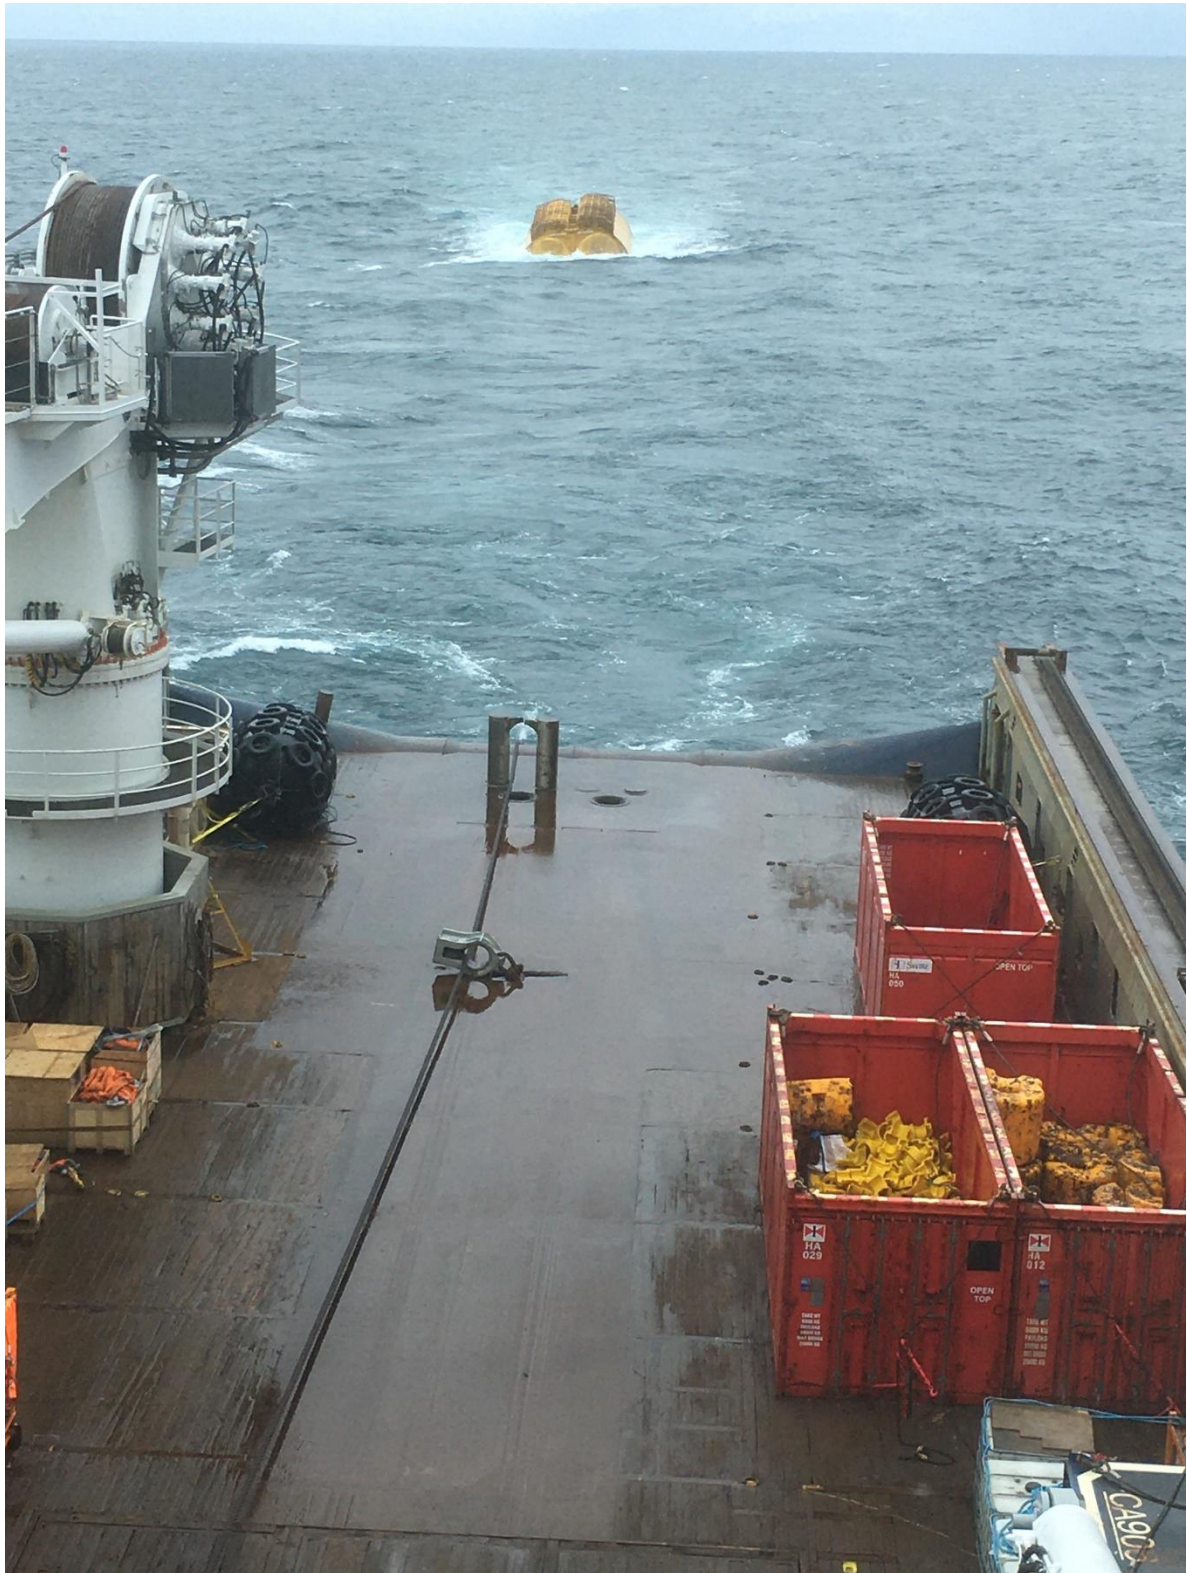
Figure 9.5.1: Mid-Water Arch viewed from back of AHV

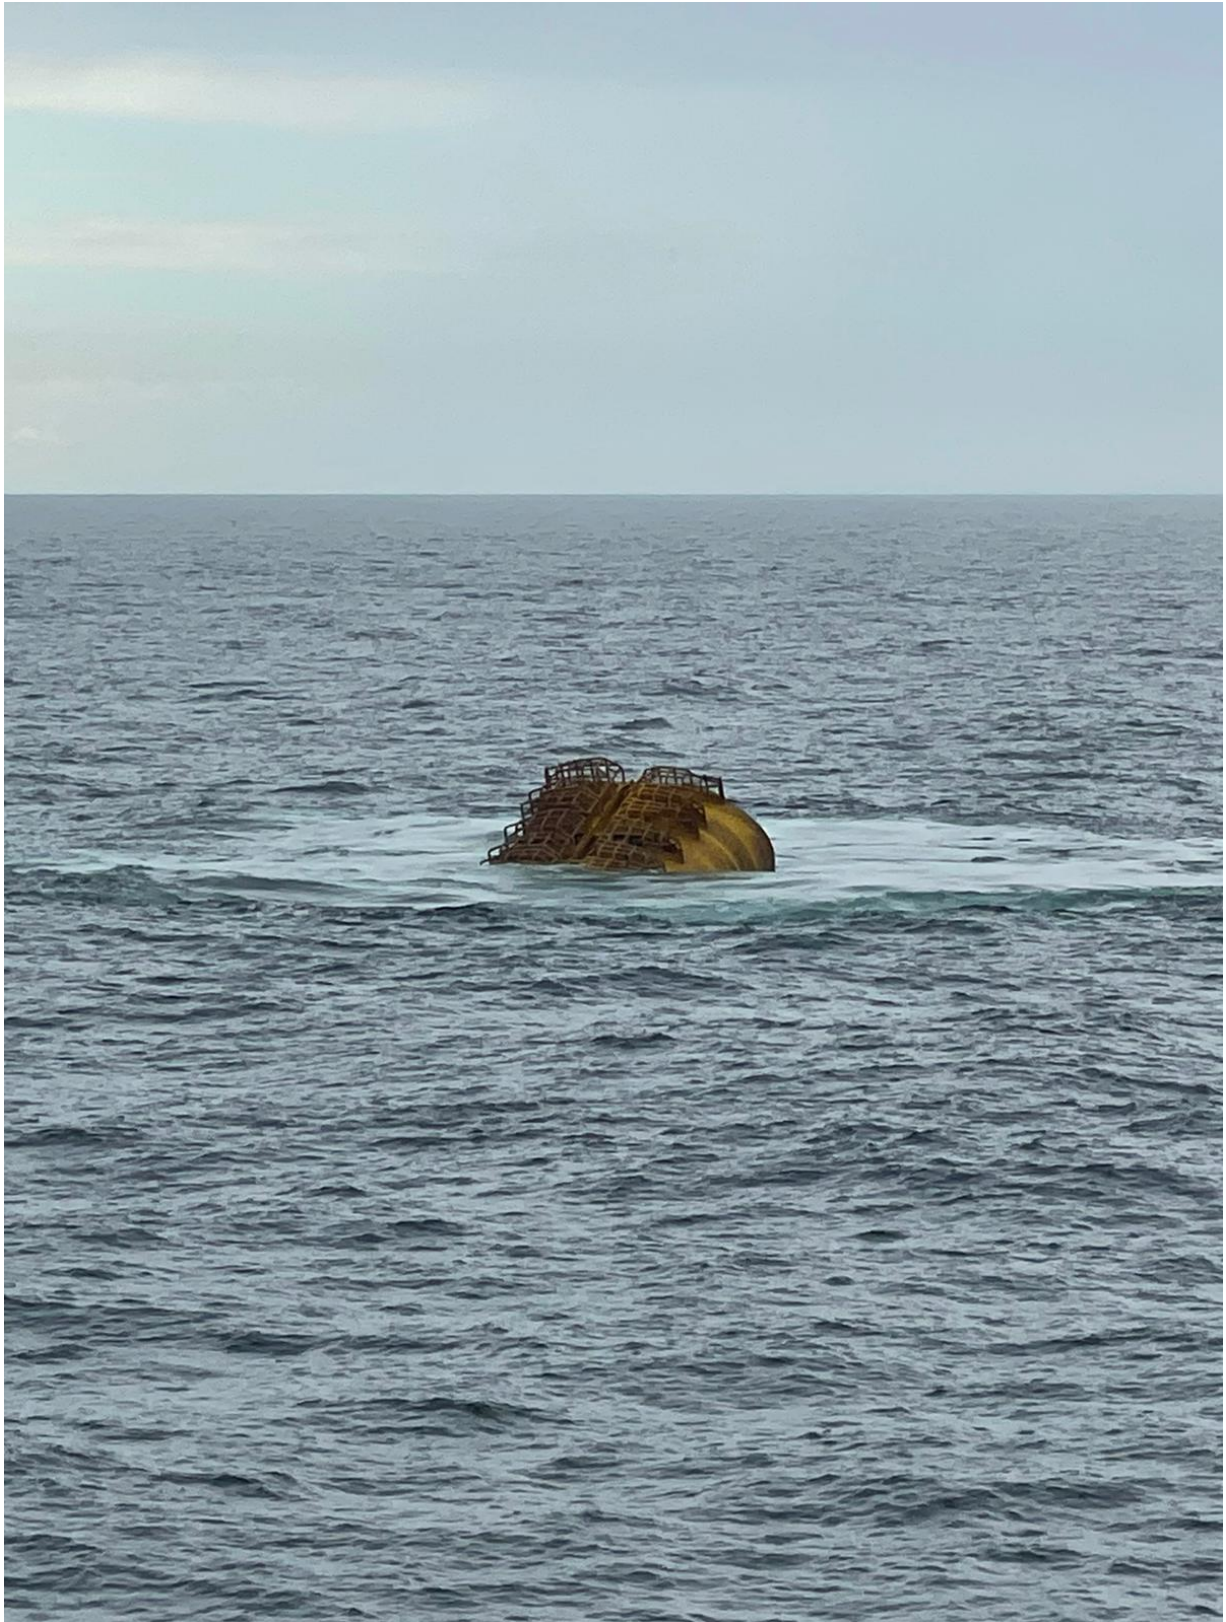
Figure 9.5.2: Mid-Water Arch stabilising from having been released

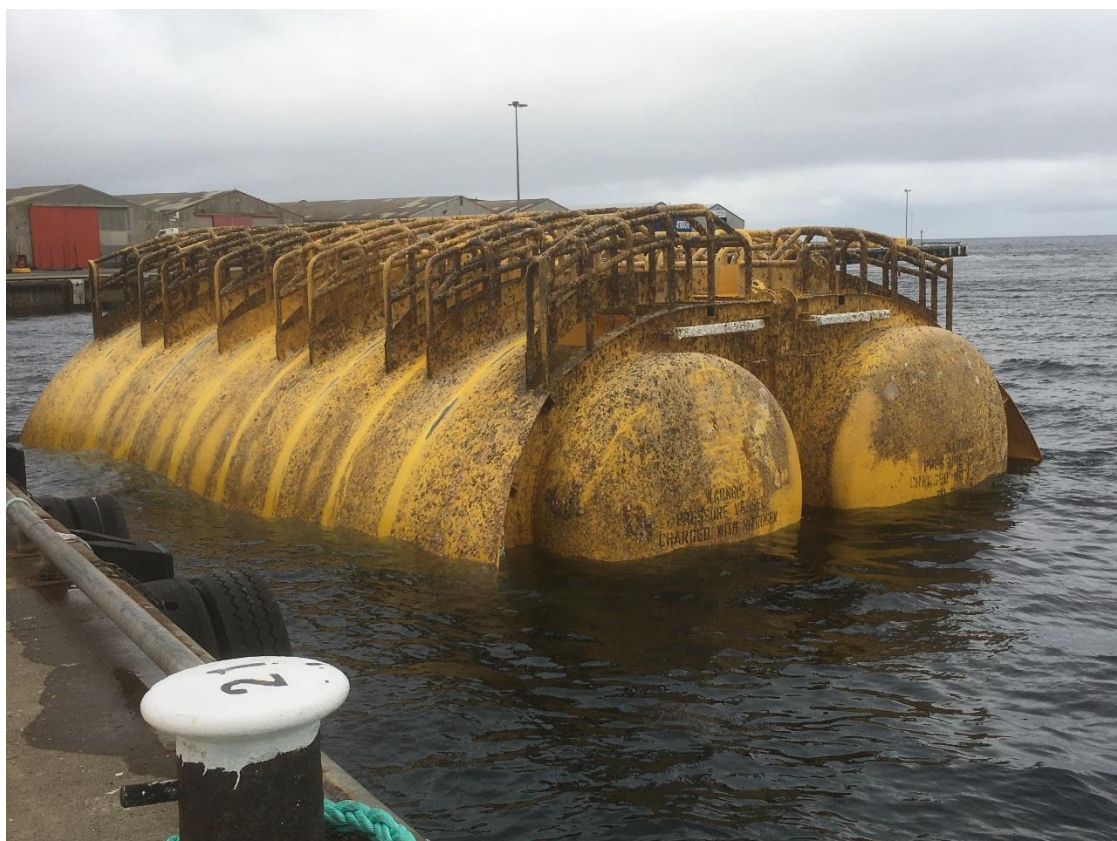
Figure 9.5.3: Mid-Water Arch alongside quayside

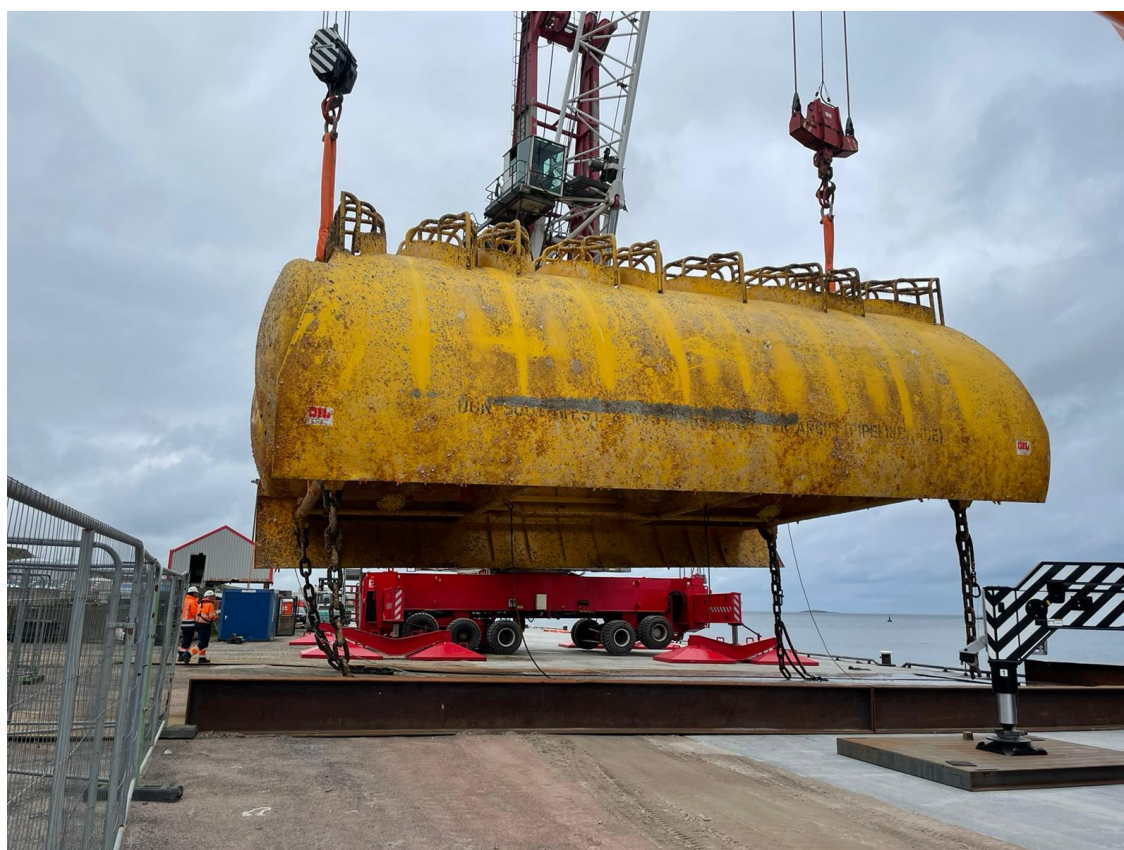
Figure 9.5.4: Mid-Water Arch lifted onto quayside

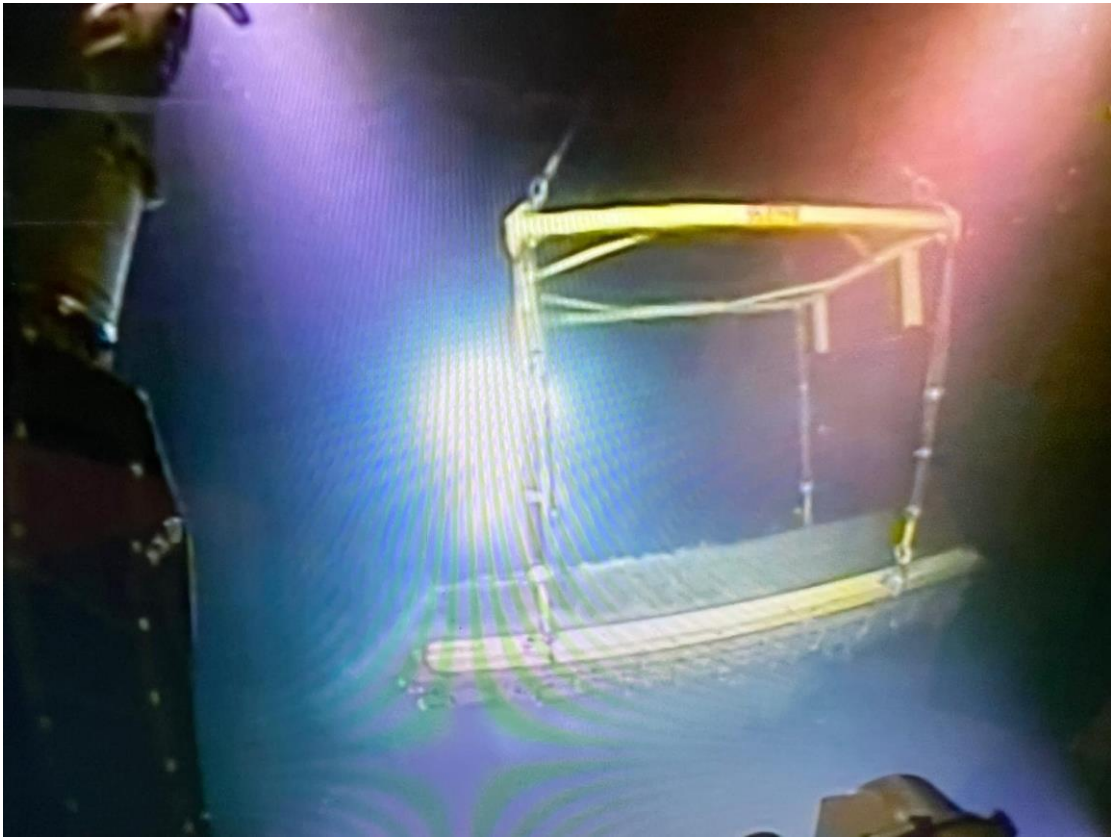
Figure 9.6.1: Concrete mattresses being recovered using a "Speedloader"
